The structural analysis and proposed consolidation methods for the Franciscan monastery in the Arad fortress

Alexandru Ion¹

Faculty of Architecture and Urbanism, Politehnica University of Timisoara, Romania¹
alexandru.ion86@yahoo.com¹

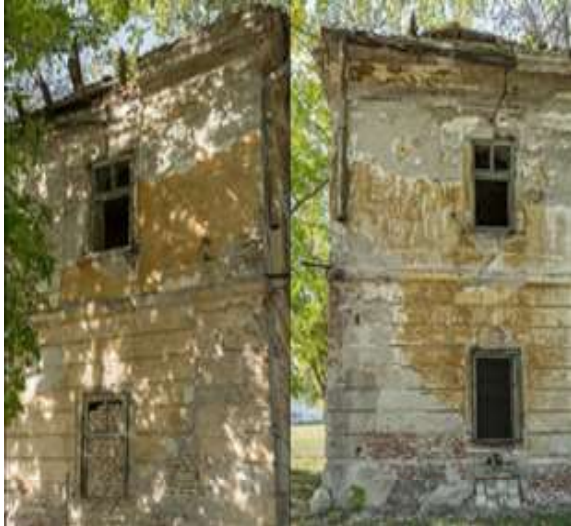
Observations were made that at the corners of the building there were vertical cracks that were caused by the faulty foundation settlement of the structure (Fig. 3).

Fig. 3. Vertical cracks at the corner of the building

that the bearing surface of the building is larger. The underpinning is executed in several stages, on a section of maximum of one meter [4].

For the consolidation of the foundation of the building the underpinning of the foundation (Fig. 14) and a perimeter beam that are both made out of reinforced concrete was chosen so

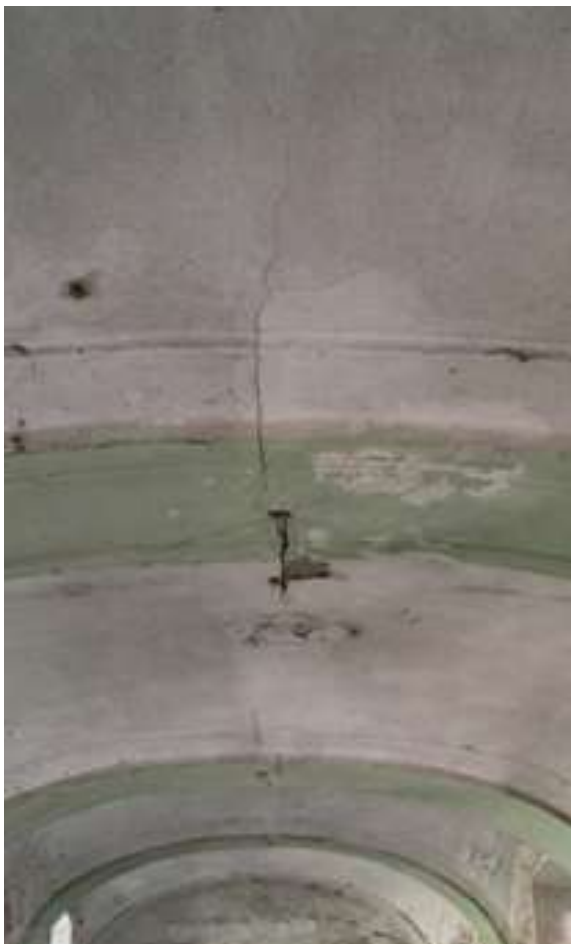
Cracks were also visible in the halls of the sanctum on the right, on the vaults and arches as seen in Fig. 4 and vertical cracks over the entrances of doors.

Fig. 4. Cracks in the arches and vaults

The consolidation method for the arches is using a steel beam that has the role of taking part of the load from the arch therefore the arch will have lower loads (Fig. 17) [4].

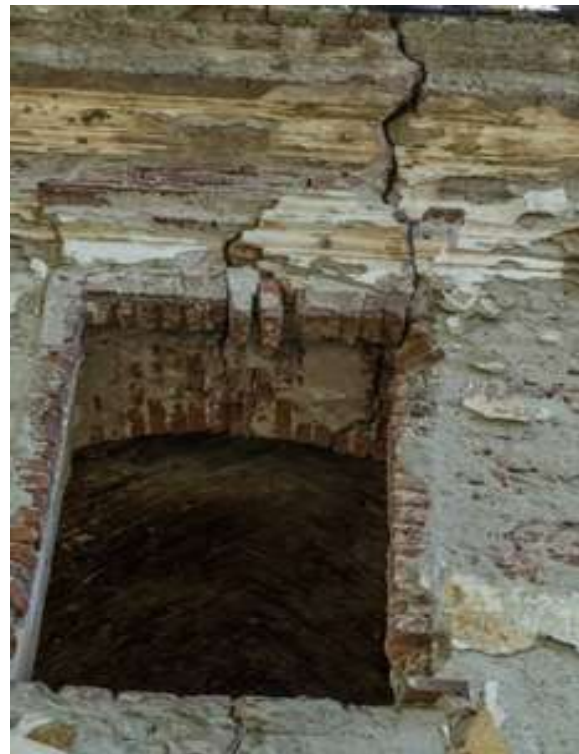
There were also vertical cracks found in the spandrel beams over the windows (Fig. 5).

Fig. 5. Cracks in the spandrel beams

For the door and window openings the consolidation with steel profiles (Fig. 16) was chosen. The intervention is done by eliminating a few rows of masonry from the superior side of the opening and from the lateral sides of approximately 70 centimeters thickness and introducing in the thickness of the wall the steel profiles double T and constraining them with metal rods [4].

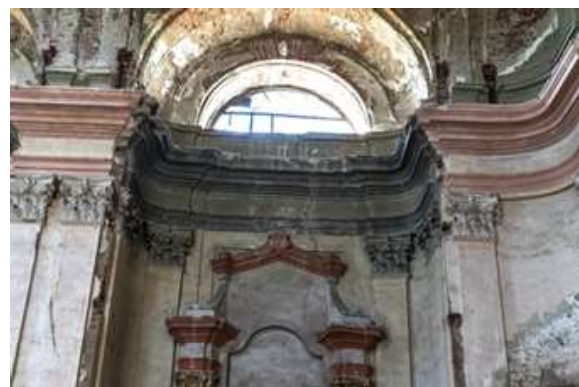
The main structure of the church has structural degradation as well. The walls of the church have vertical cracks because of water infiltration in the foundation (Fig. 6).

Fig. 6. Cracks in the monastery walls

For the walls the coating of the walls with galvanized steel nets and pure hydraulic lime mortar (Fig. 15) was chosen. The masonry can be coated on both sides of the wall. The nets are bound

together with steel connectors which are introduced through holes made in the wall from both sides [4].

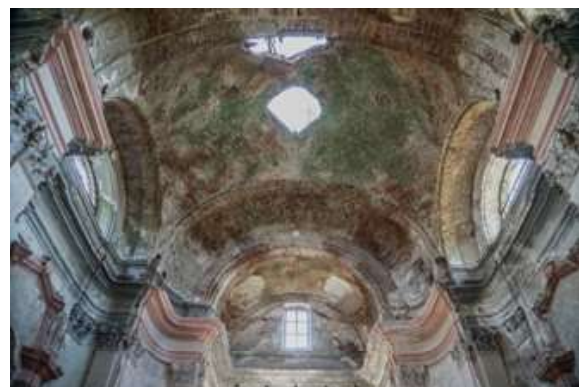
Also some vaults in the church and some vaults in the sanctum are partially or completely col-

lapsed (Fig. 7, Fig. 8) because the roof over the church and parts of the sanctum are completely gone and the water infiltrated these vaults.

Fig. 7. Partially collapsed vault in the church

The same method as for the arches was picked for the vaults of the church but instead of a single steel beam there will be a network of steel beams that change how the loads affect the vault (Fig. 18) [4].

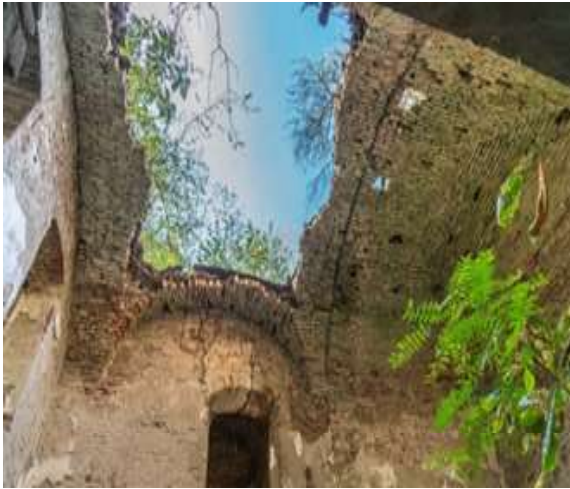
Fig. 8. Completely collapsed vault in the sanctuary

The vaults over the sanctums shall be consolidated with composite FRP materials that will help strengthen the structure (Fig. 19).

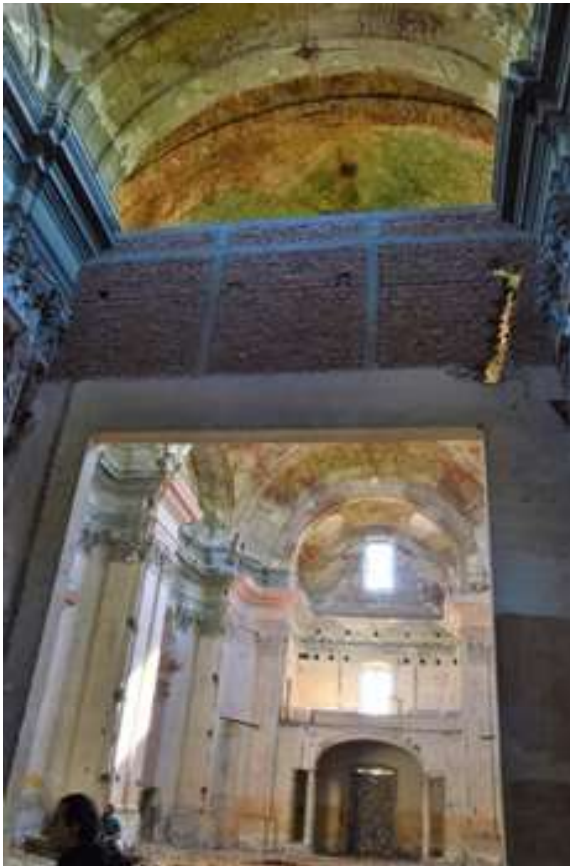
There were also some unauthorized interventions done to the structure like holes done in walls for passing, some windows and walls were blocked with masonry and a masonry wall with RC frame was built in the church (Fig. 9).

Fig. 9. Unauthorized masonry wall with RC frame

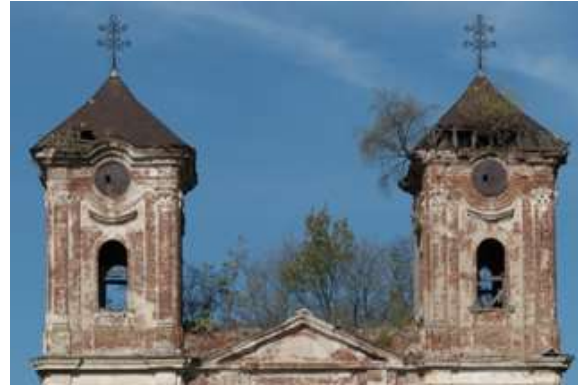
A complete analysis of the structure was not possible because access was not possible to the sanctuary left of the church, the roof or to the basement. Observations were made that the roof is missing over the church because of the collapse of the vaults, and from the outside that where the roof is missing vegetation has started to grow in those places (Fig. 10).

Fig. 10. Vegetation taking over where the roof used to be

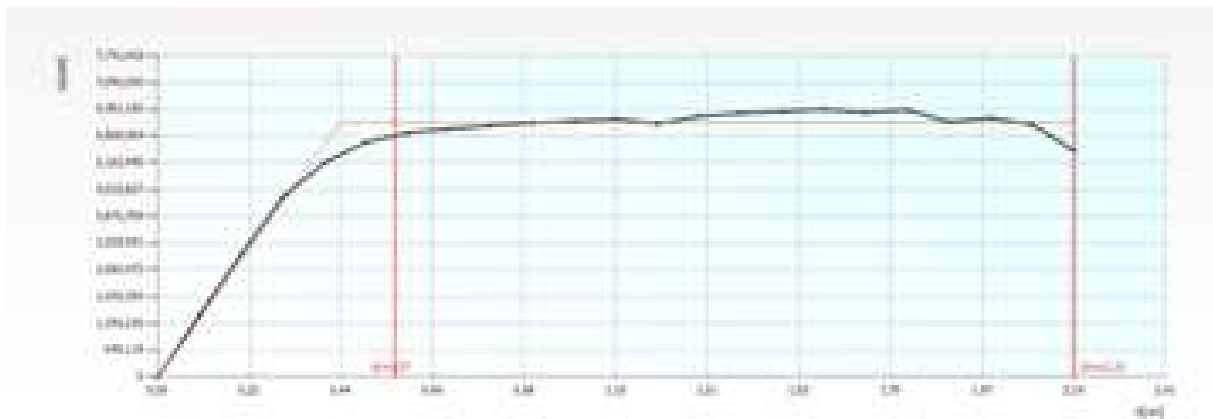
analysis results gave Fig. 12 as the force-displacement curve for the structure.

Fig. 12. Force-displacement curve [2]

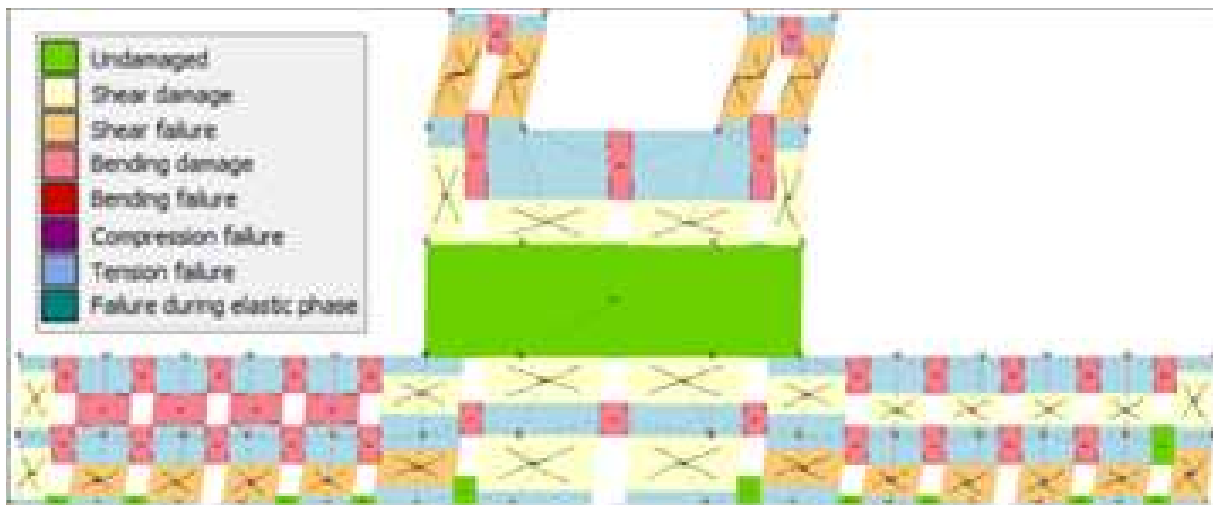
After that the degradations of the structure after an earthquake with 0.20g ground acceleration were also possible to view. Fig. 13 represents the damage that the main façade can get after such an earthquake.

Fig. 13. Degradations of the main façade [2]

After viewing the analysis results a deduction was made that the structure would sustain high damage after an earthquake with 0.20g ground acceleration.
